Investigation of L'Ambiance Plaza Building Collapse in Bridgeport, Connecticut

Center for Building Technology
National Engineering Laboratory
National Bureau of Standards
Gaithersburg, MD 20899

Charles G. Culver
Charles F. Scribner
Richard D. Marshall
Felix Y. Yokel
John L. Gross
Charles W. Yancey
Erik M. Hendrickson

Issued September 1987

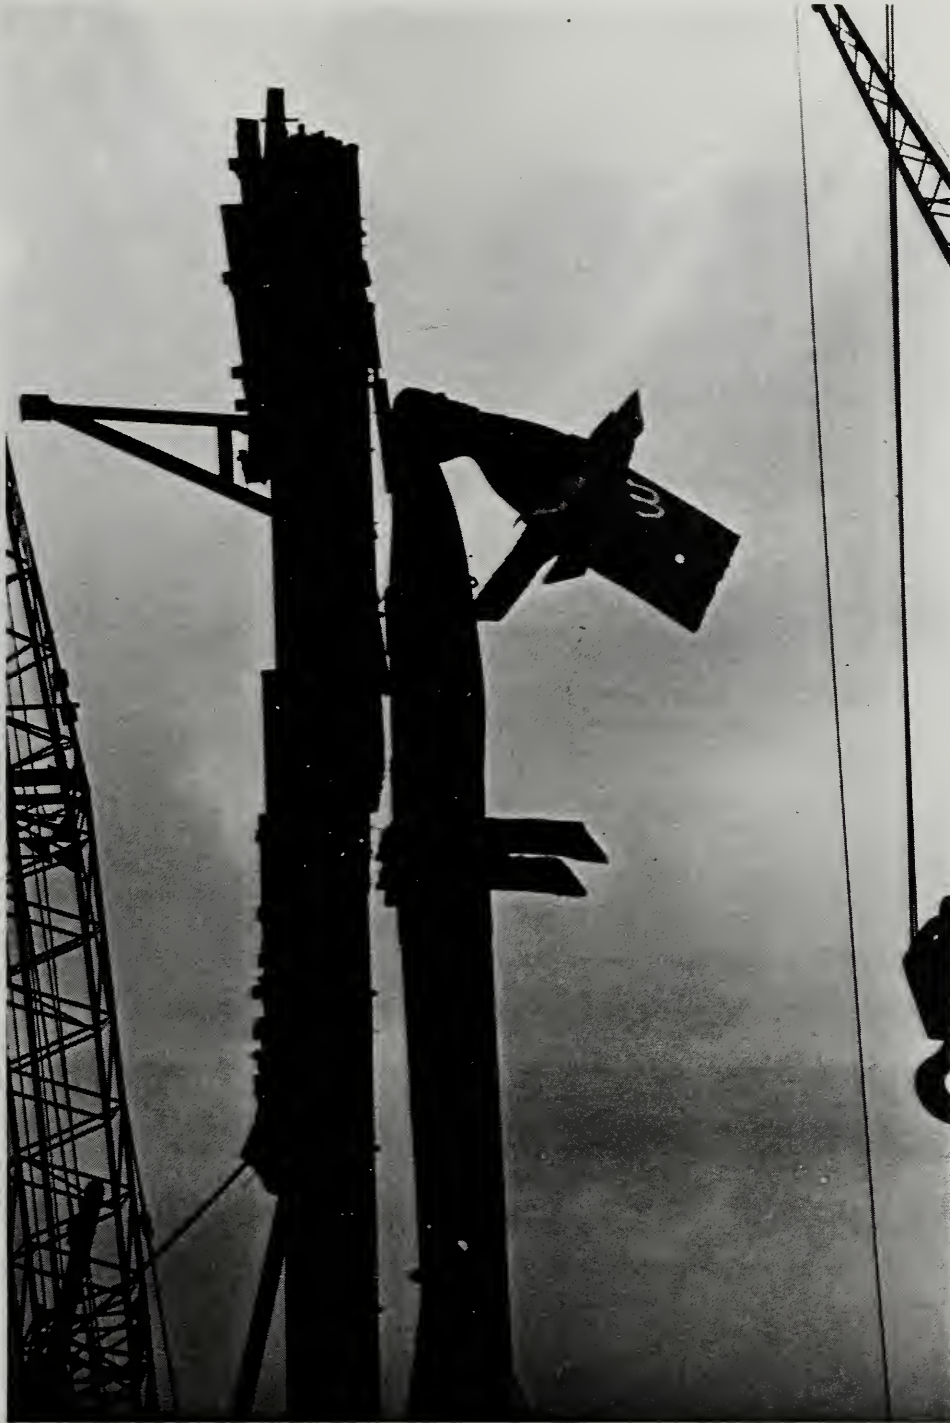
Figure 4.4.2 Column C3 bending about the strong axis –
View to the East, shearwall on left

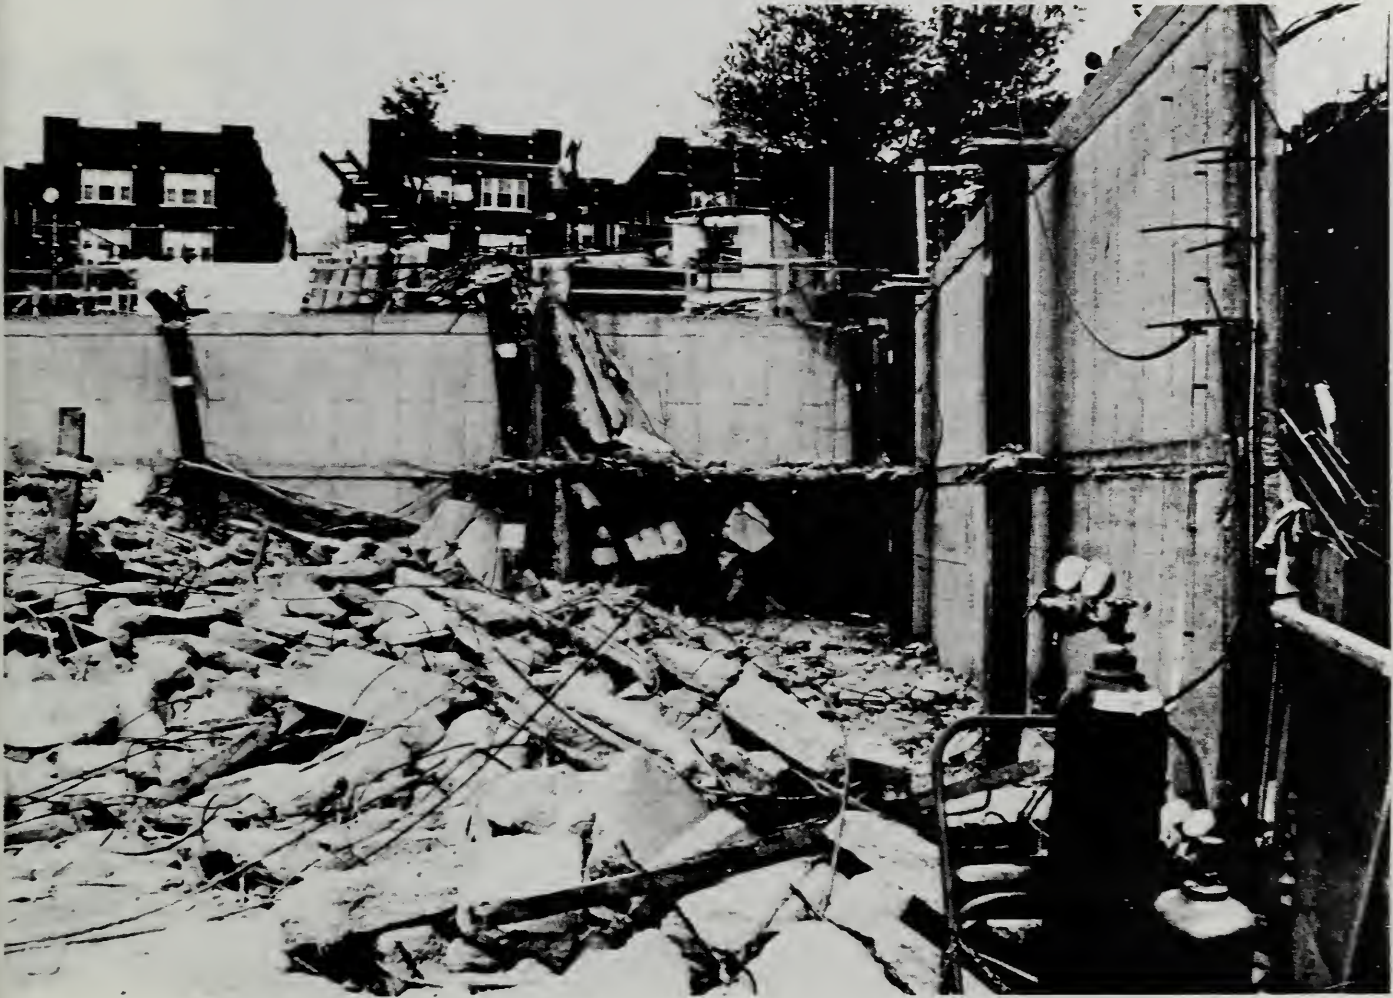
Figure 4.4.4 East perimeter columns at Levels E and D. East tower—View to the North; photo taken after rescue operations complete

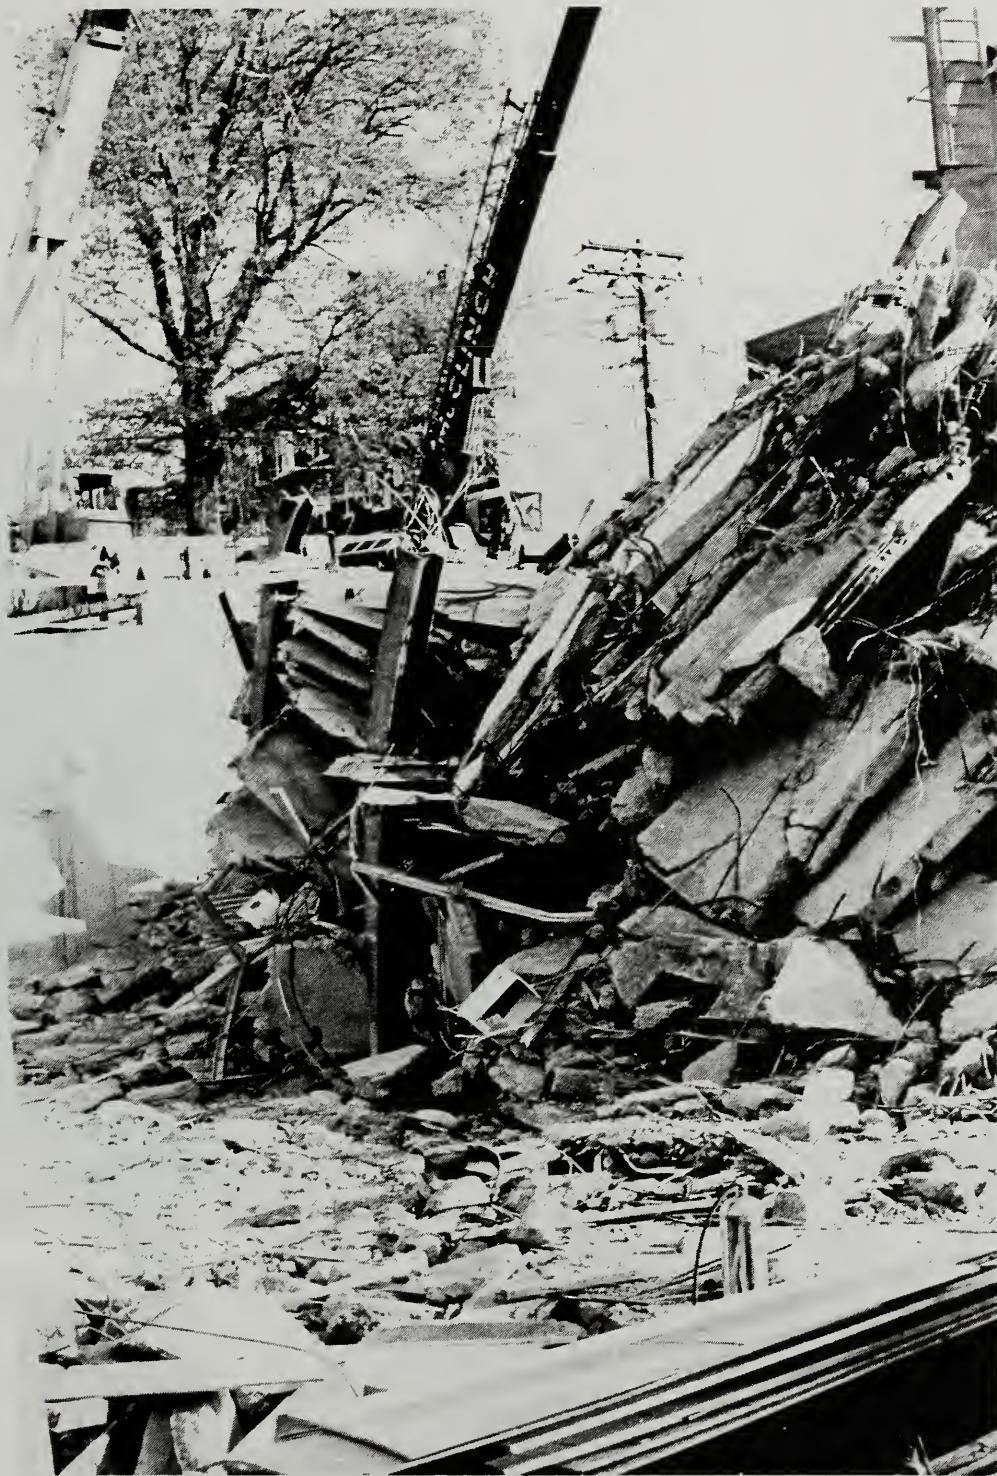
Figure 4.4.8 Lower level floor slabs at Northwest corner of West tower – View to the North; column E1

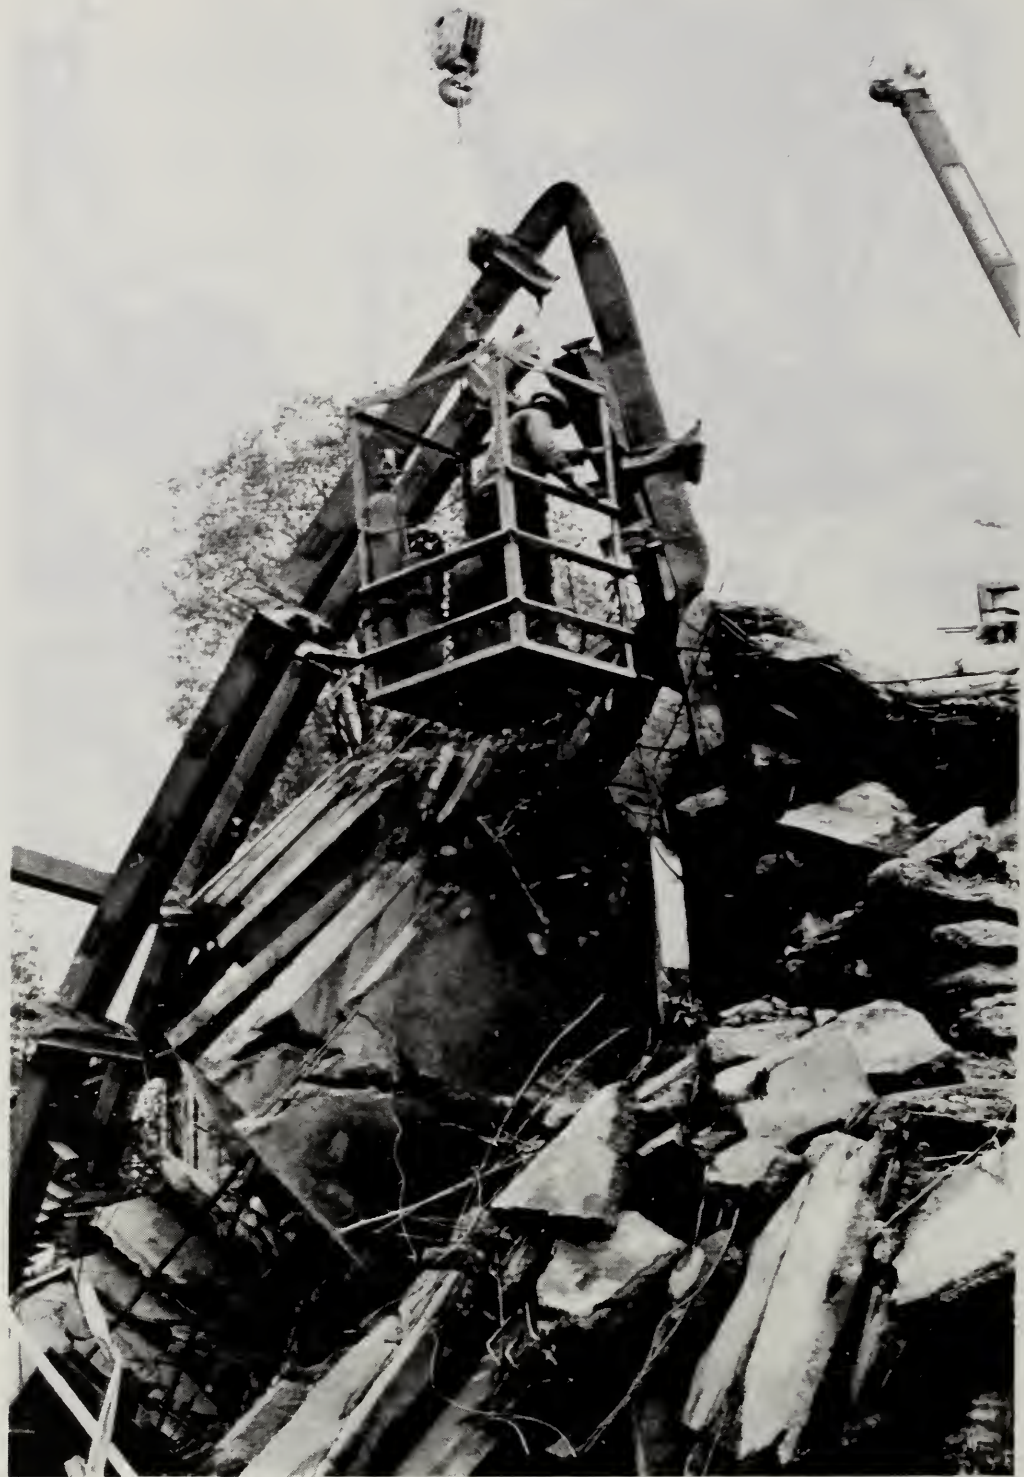
Figure 4.4.9 Upper floor slabs on Northwest corner of West tower – View to the North; column E1

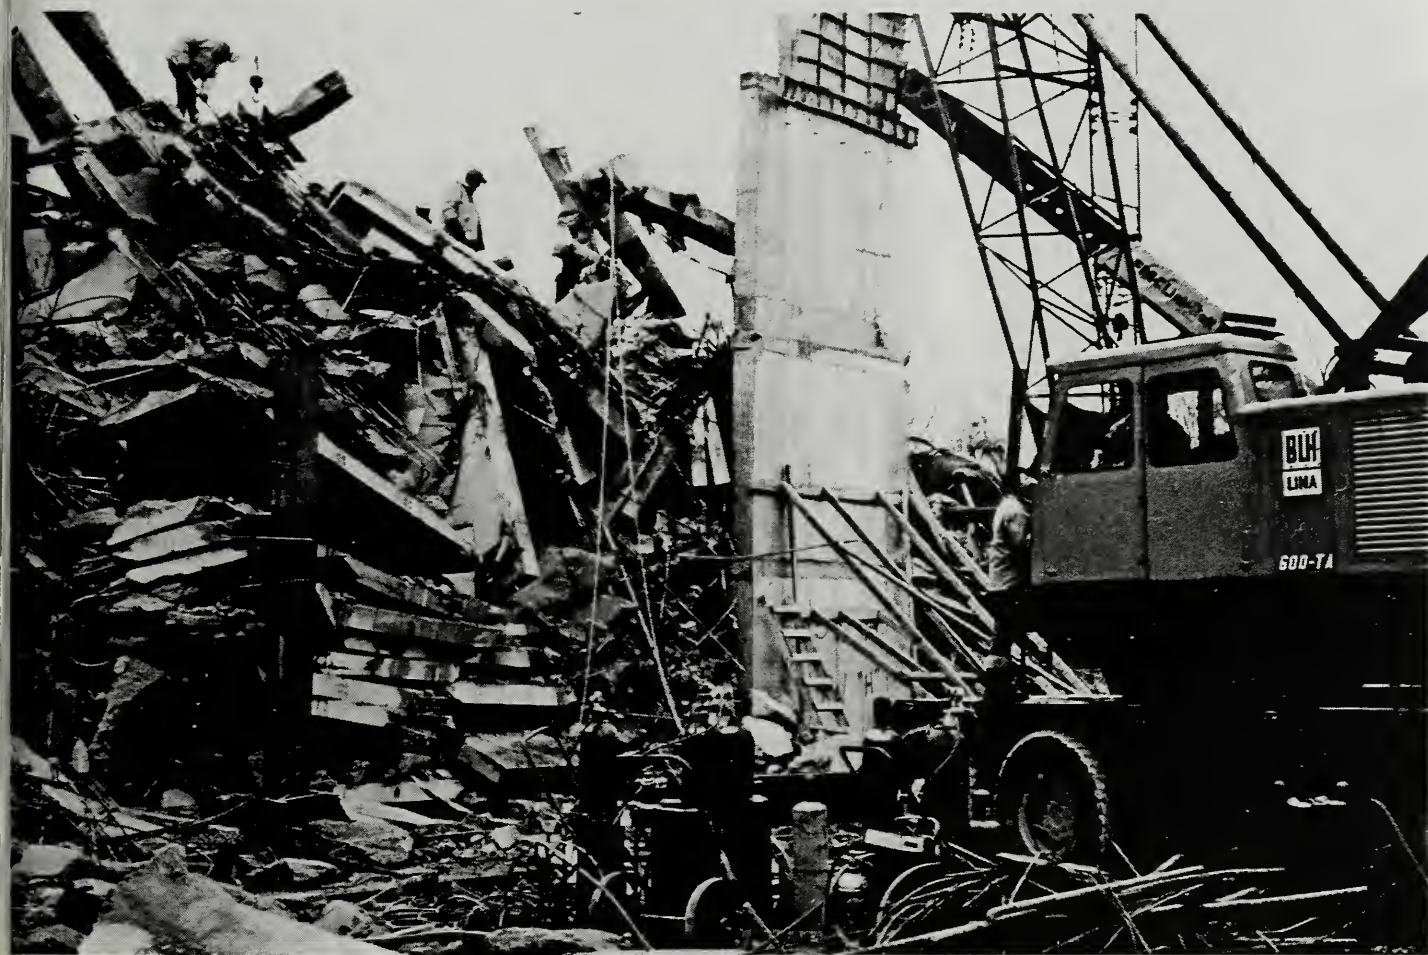
Figure 4.4.10 Lower level floor slabs in center portion of West tower – View to the Northeast

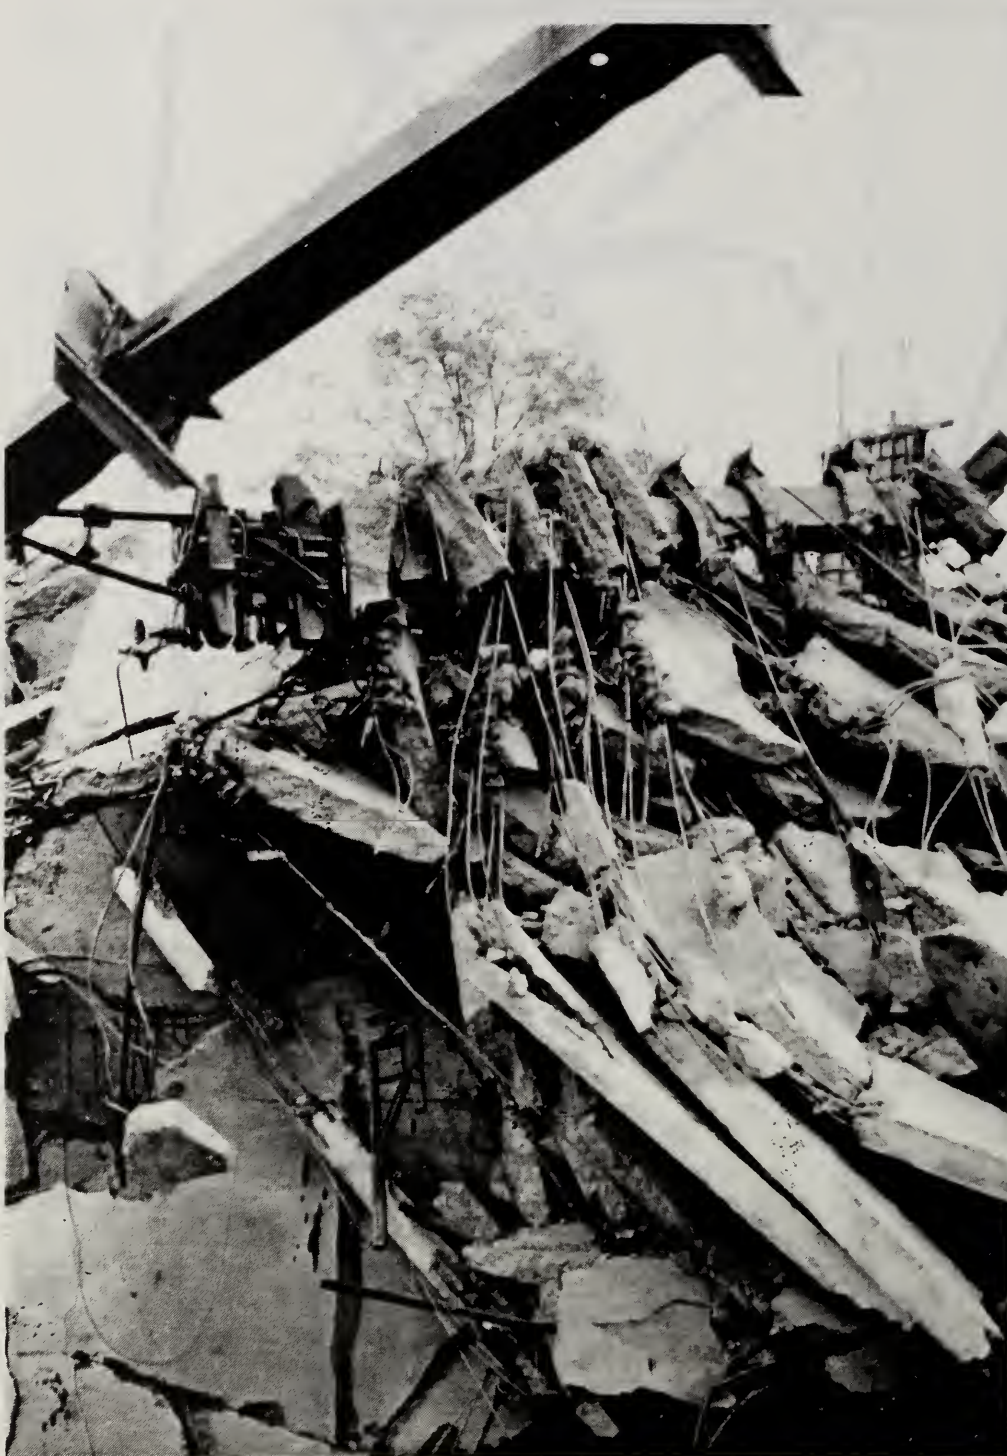
Figure 4.4.15 Separation of floor slabs from shearheads

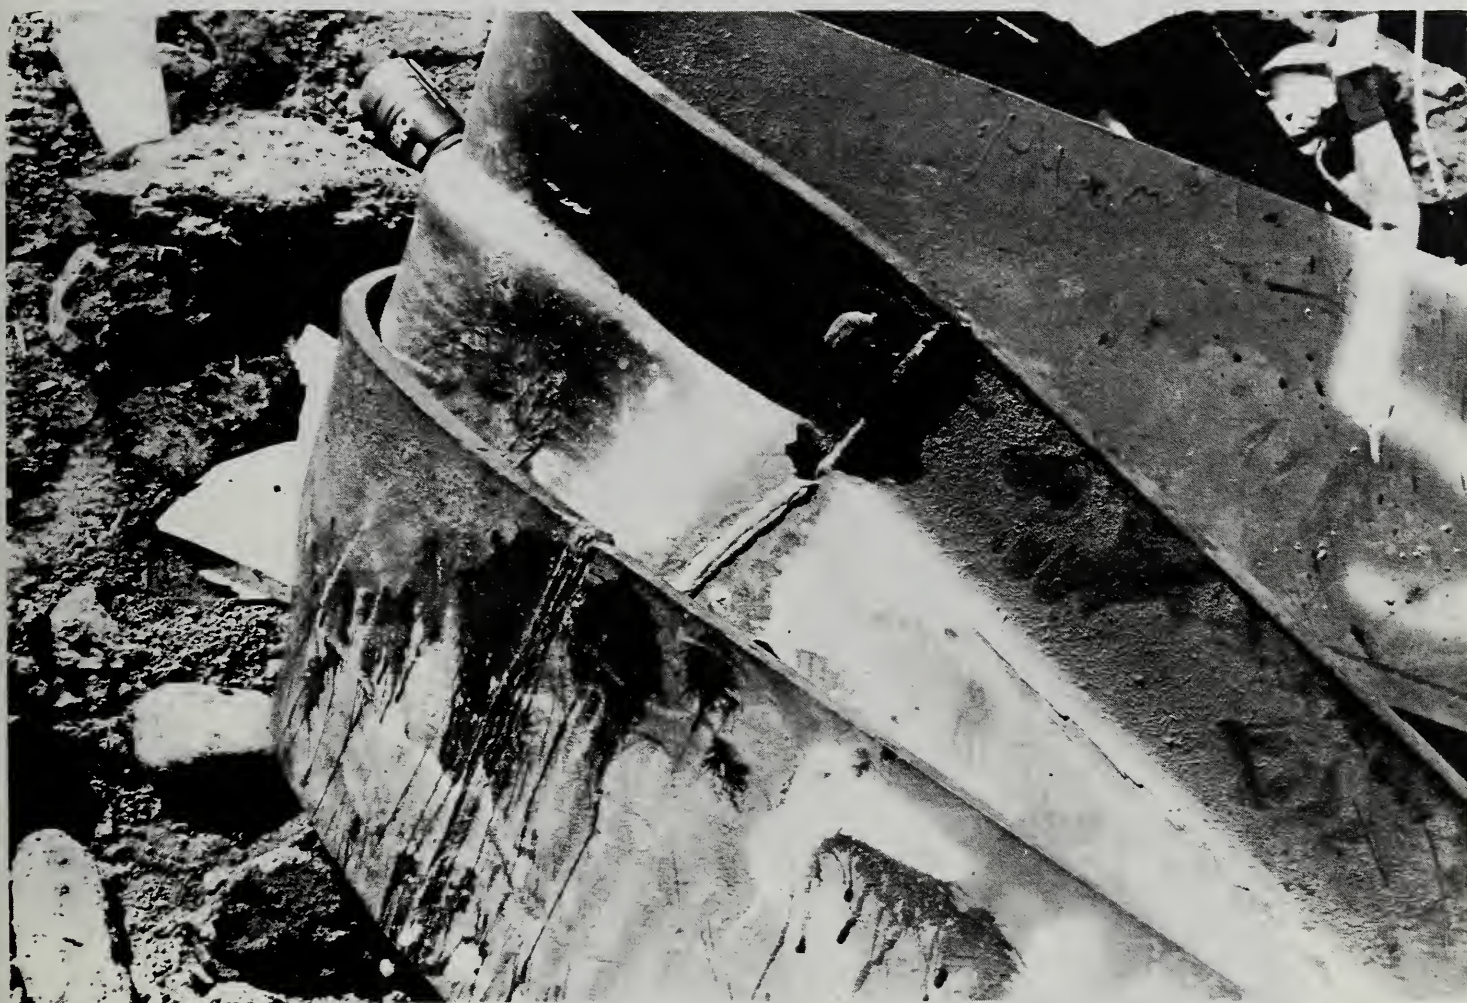
Figure 4.4.22 Deformation at column splice

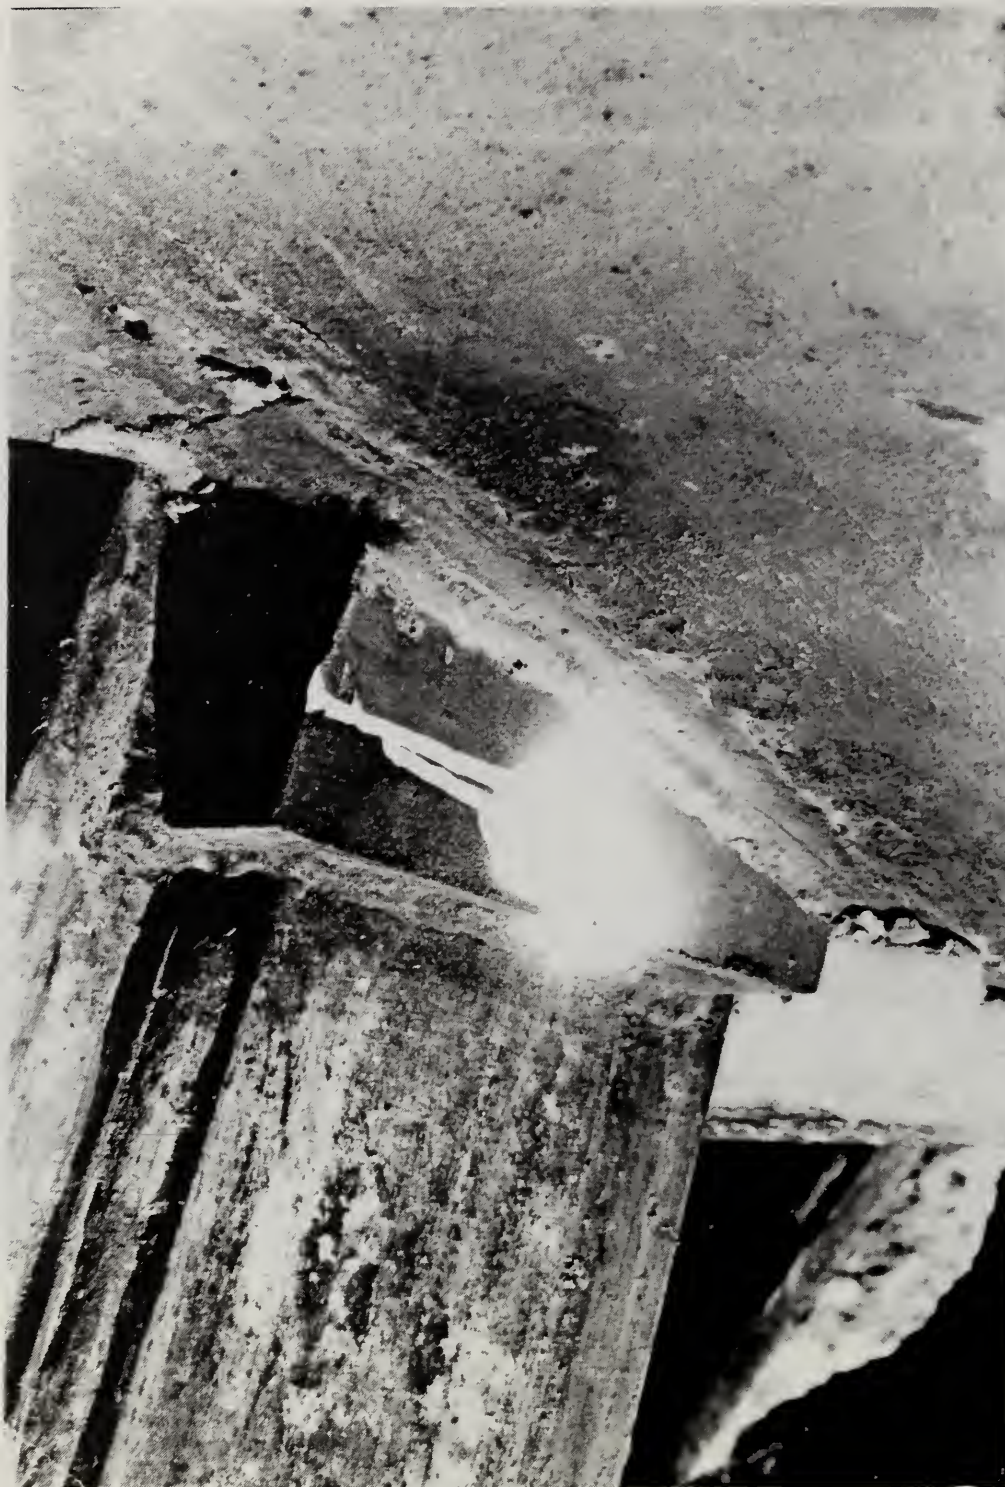
Figure 4.4.23 Intact shearhead support

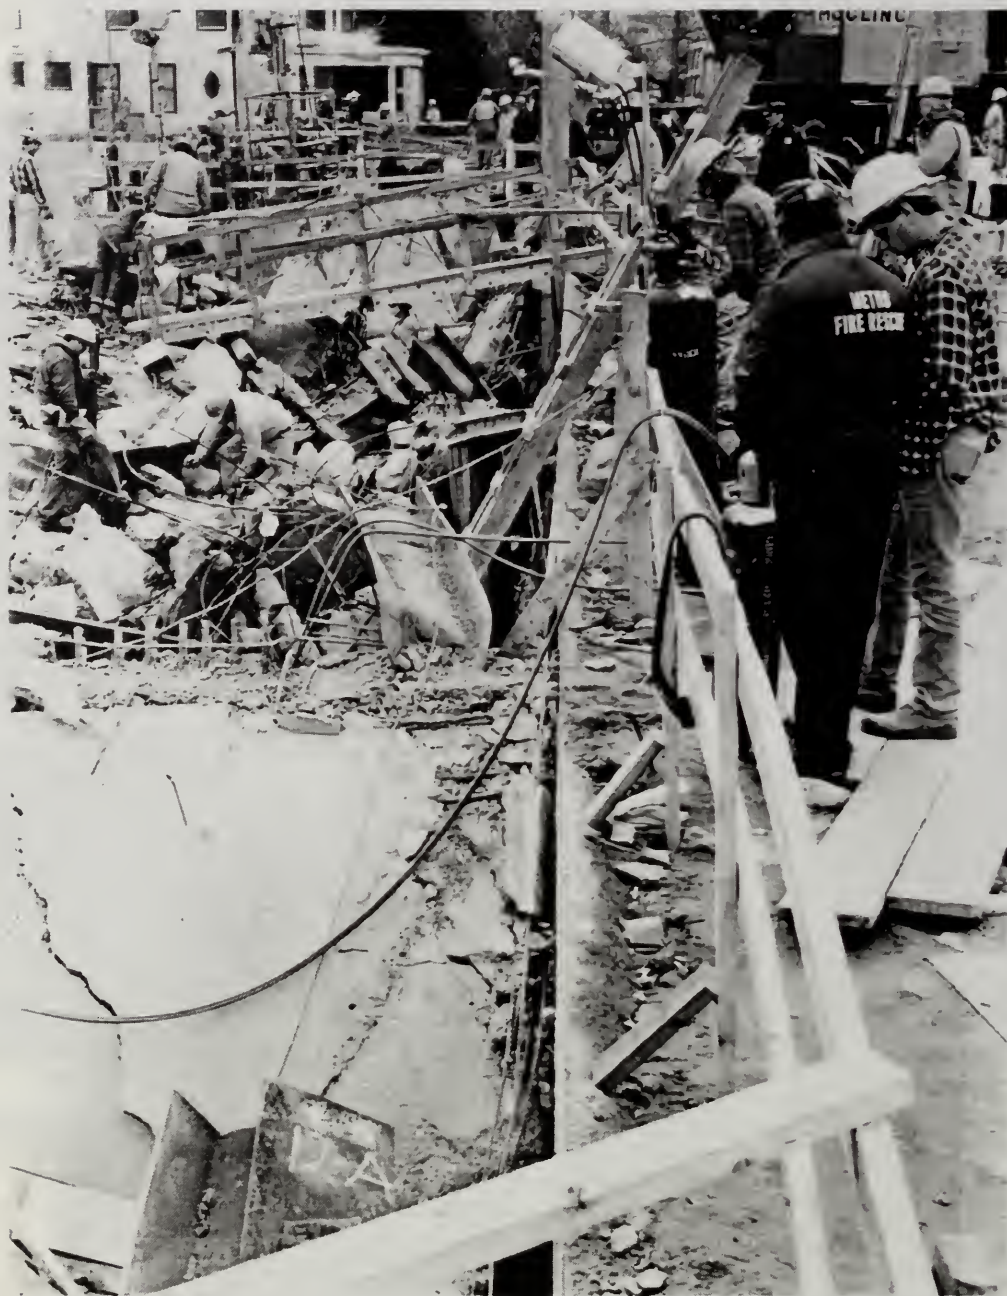
Figure 4.4.29 Basement wall on North side of East Tower – viewed from the East, May 1, 1987

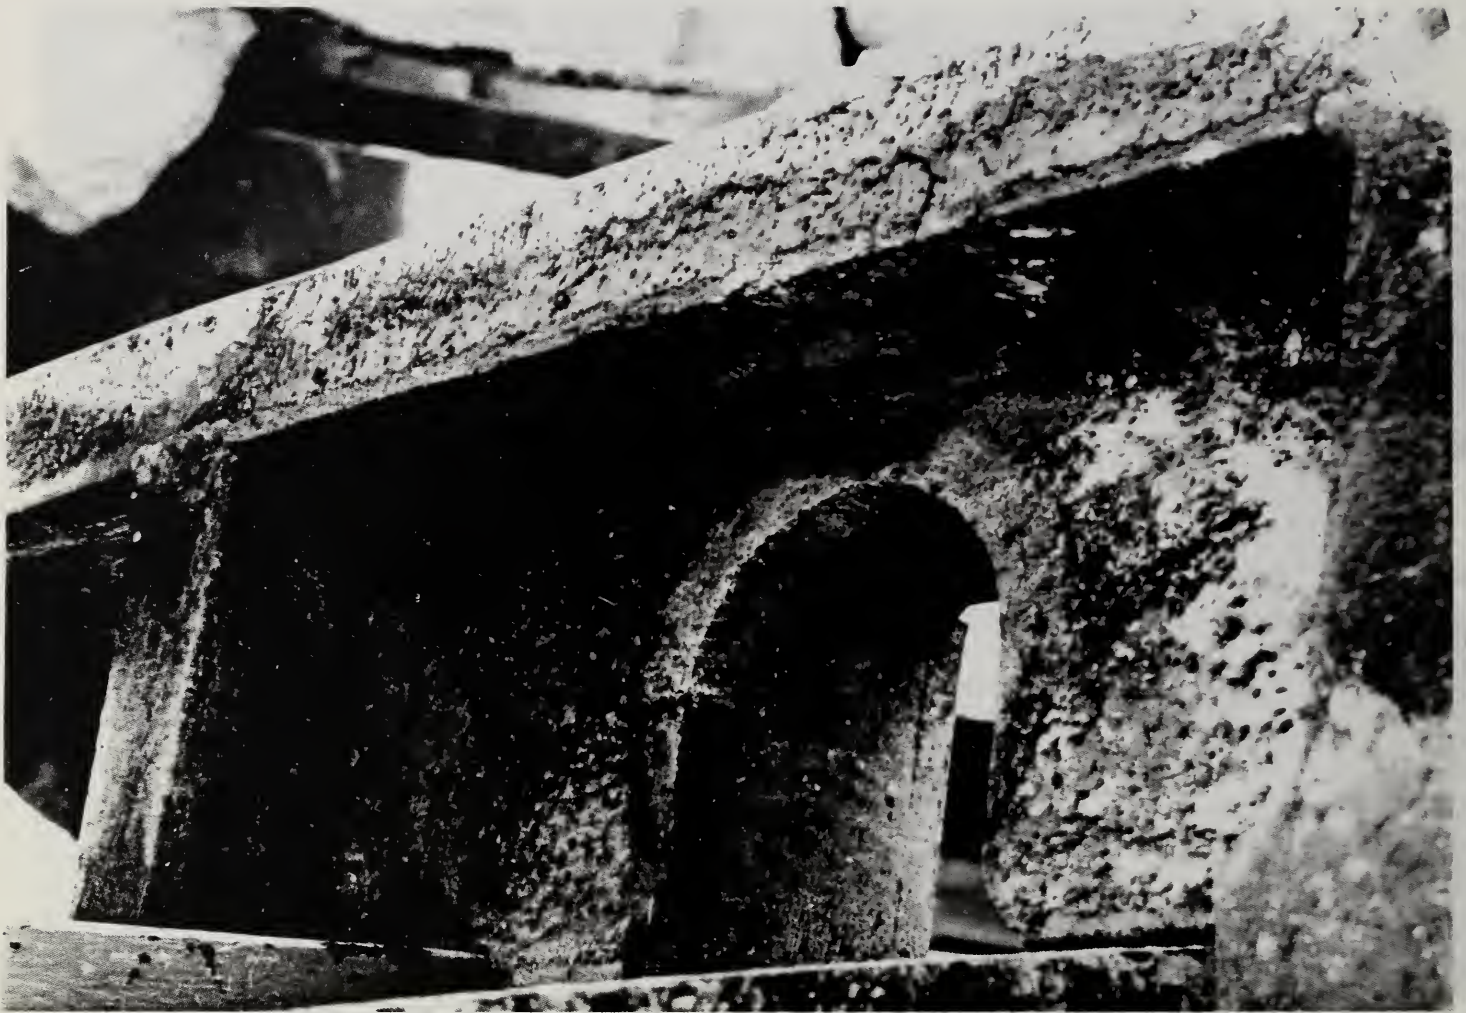
Figure 4.4.33 Typical indentation in underside of lifting angle

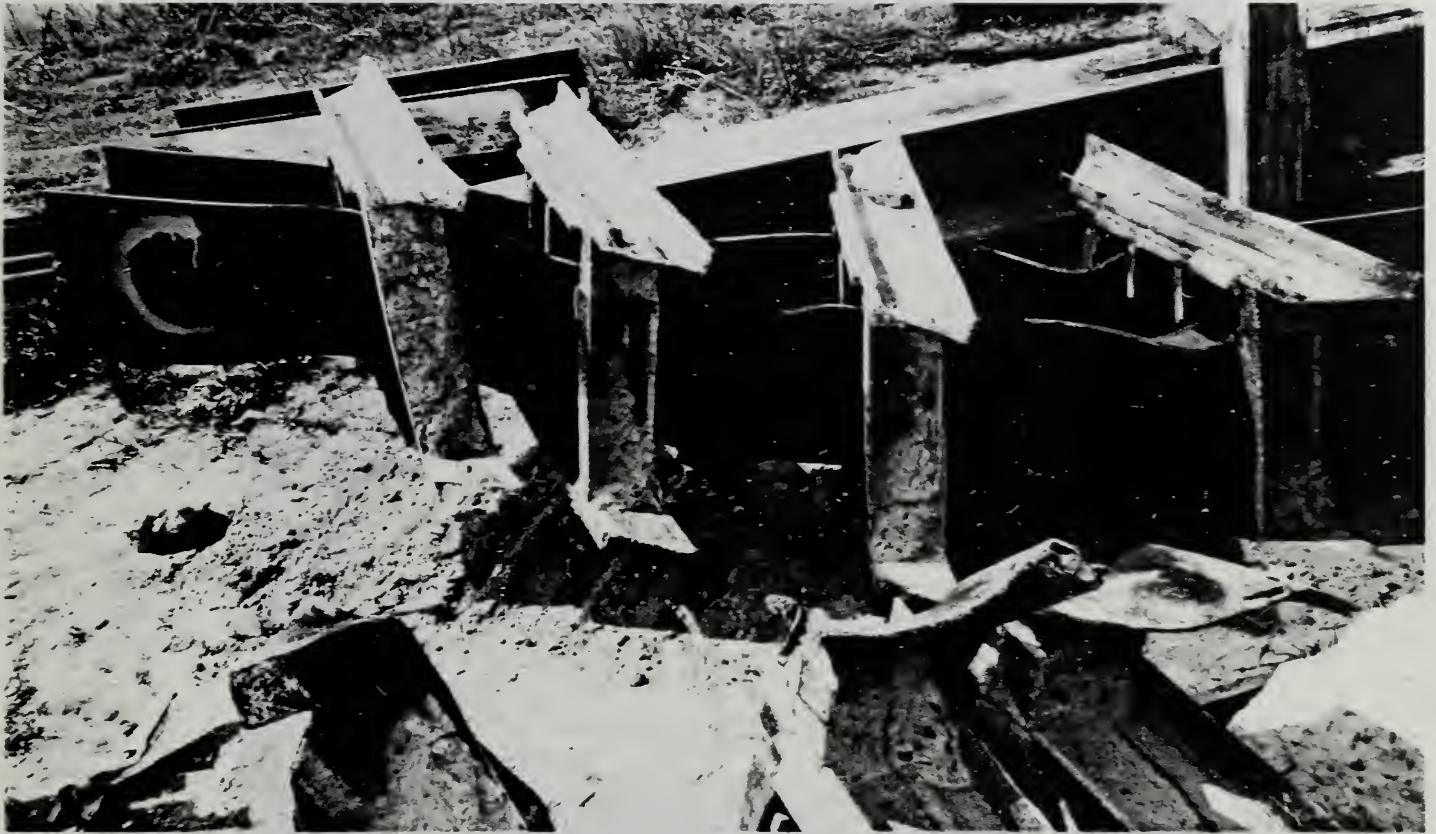
Figure 4.4.34 Deformation of column C4.8 in stage IV

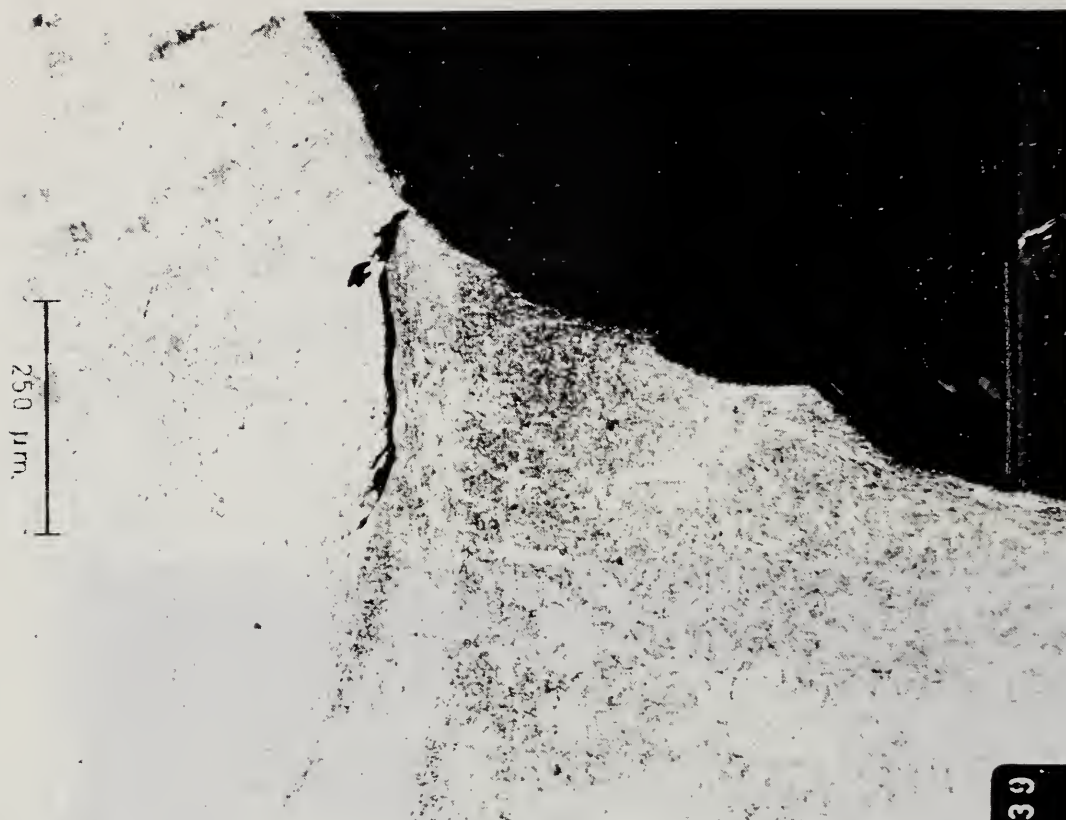
Figure 5.4.3 Cross section showing weld in sample NBS 21-3A-2 (x 100)

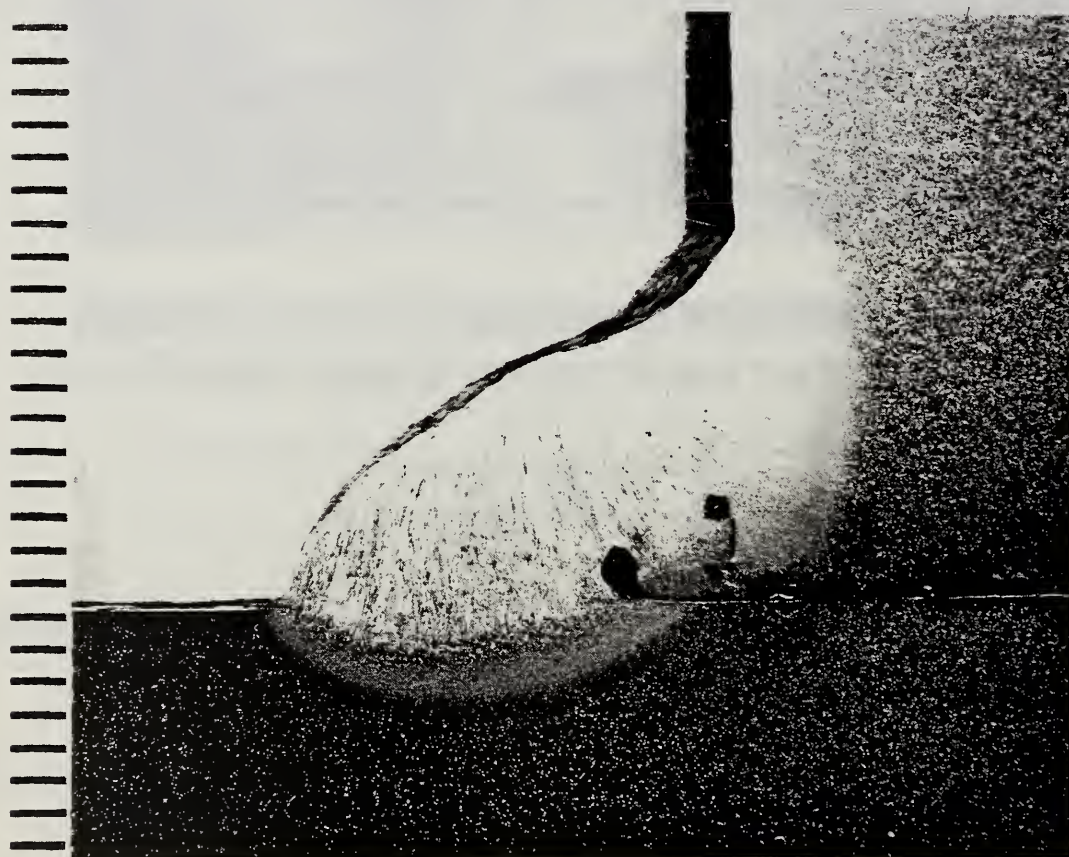
Figure 5.4.4 Cross section showing weld in sample NBS-3A-3 (x 4)

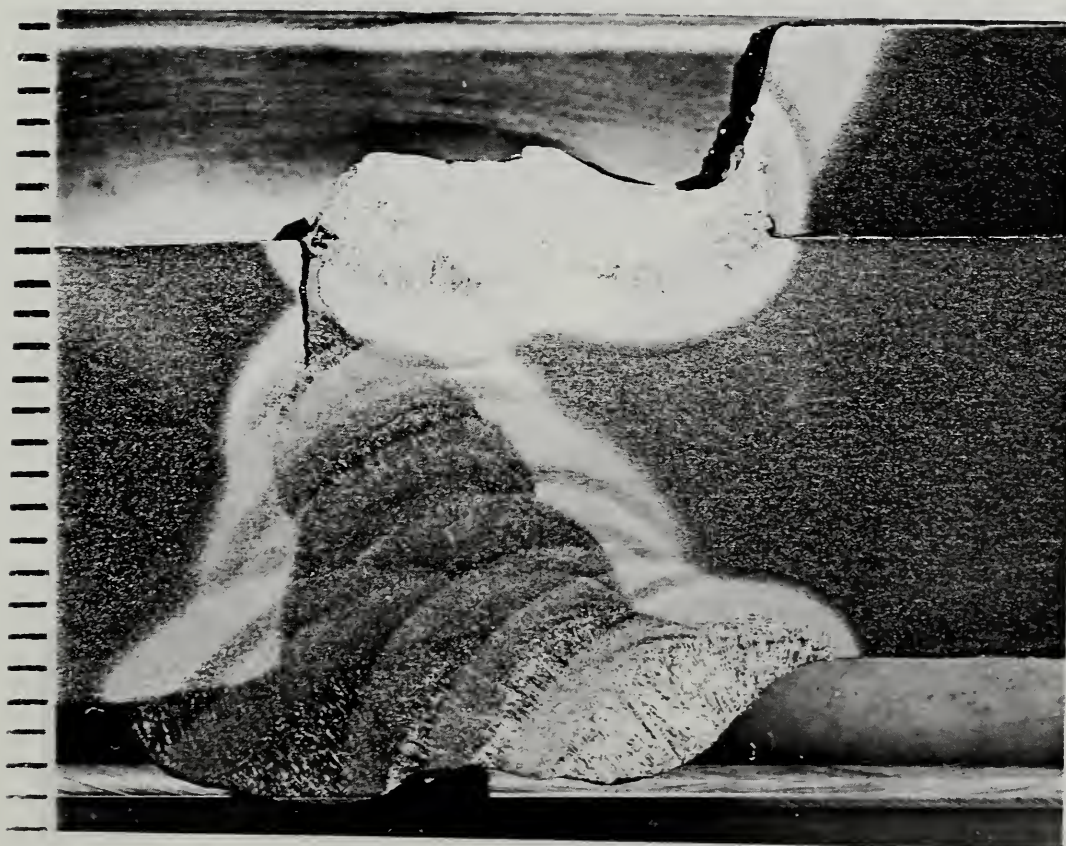
Figure 5.4.6 Cross section showing weld in specimen NBS 8-T1 (x 4)

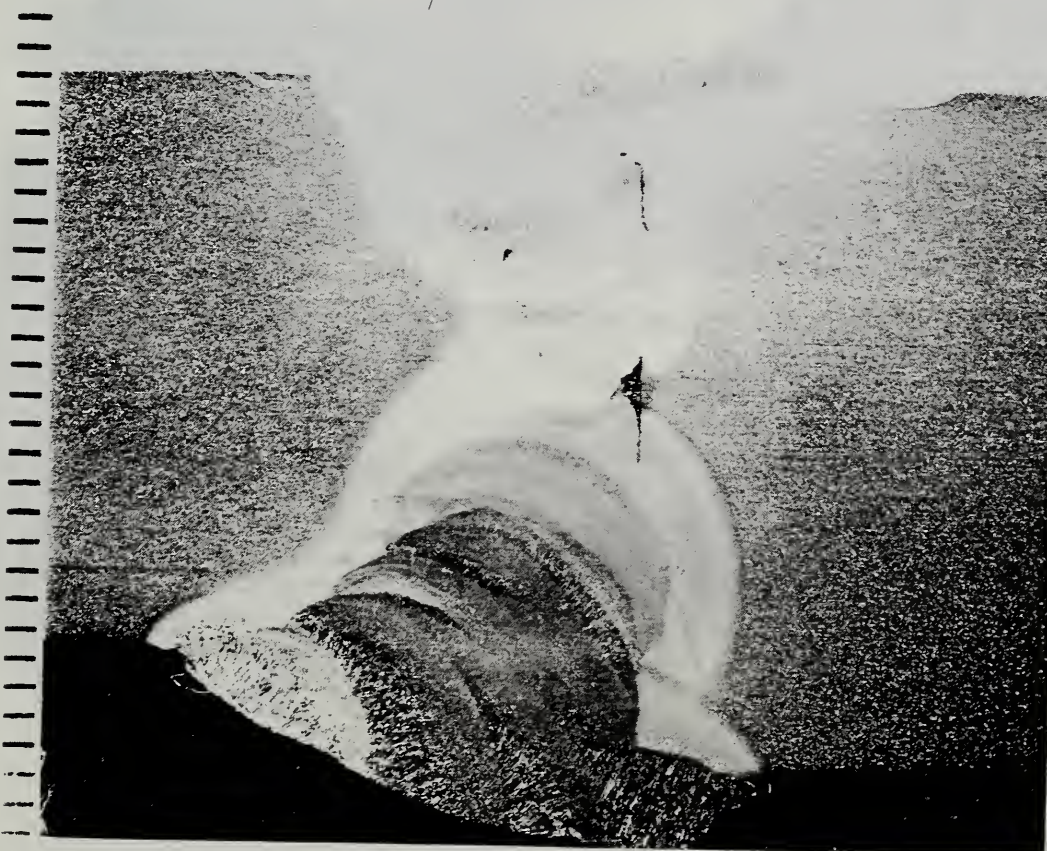
Figure 5.4.10 Cross section showing the weld in specimen NBS 4-F1 (x 4)

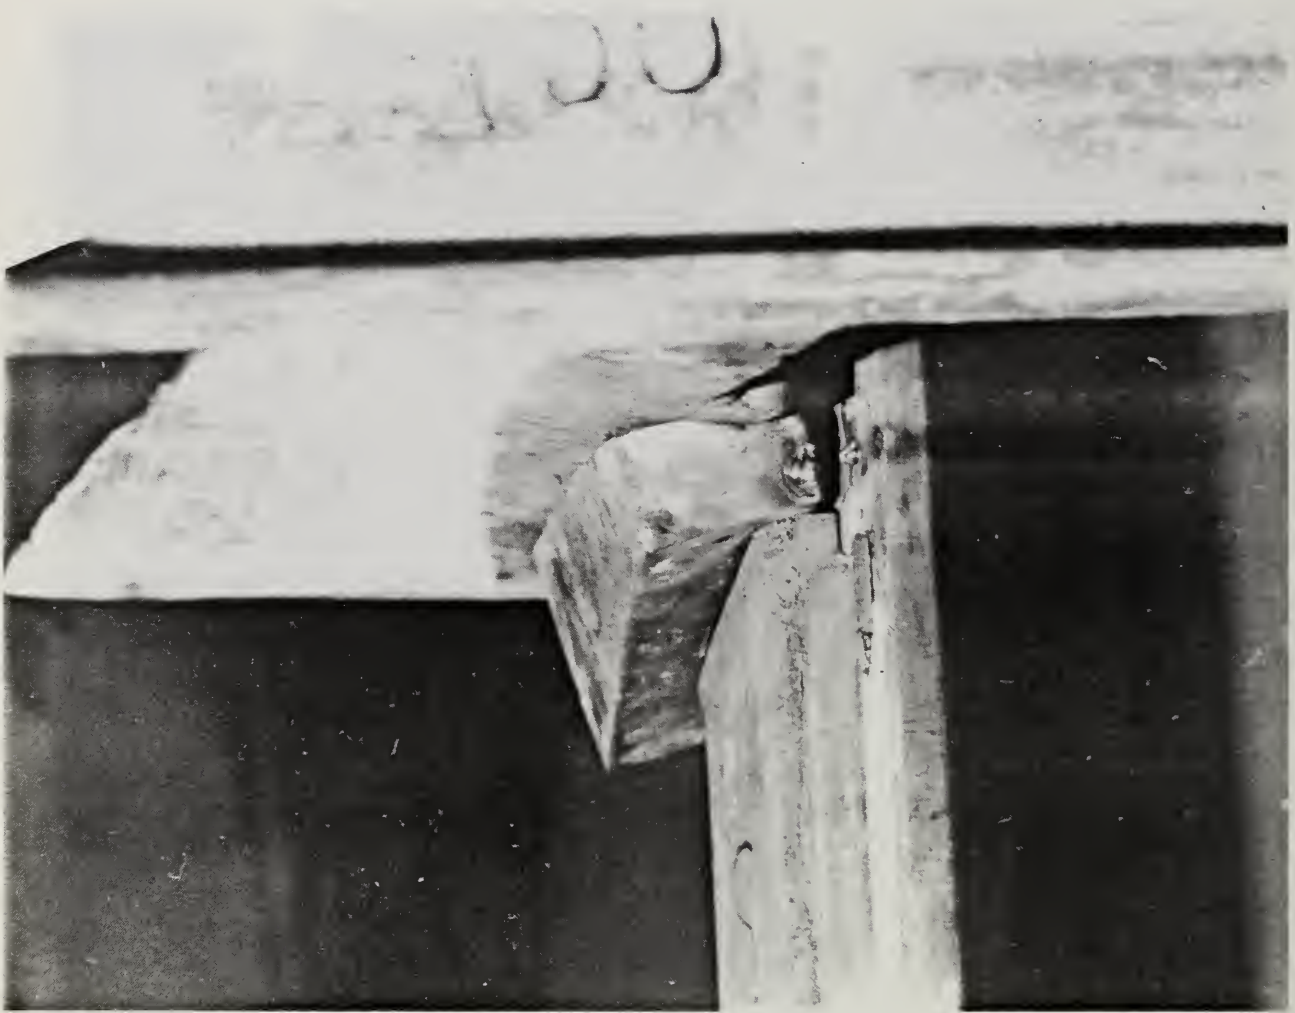
Figure 5.5.12 Deformation of shearhead channel in test of shearhead

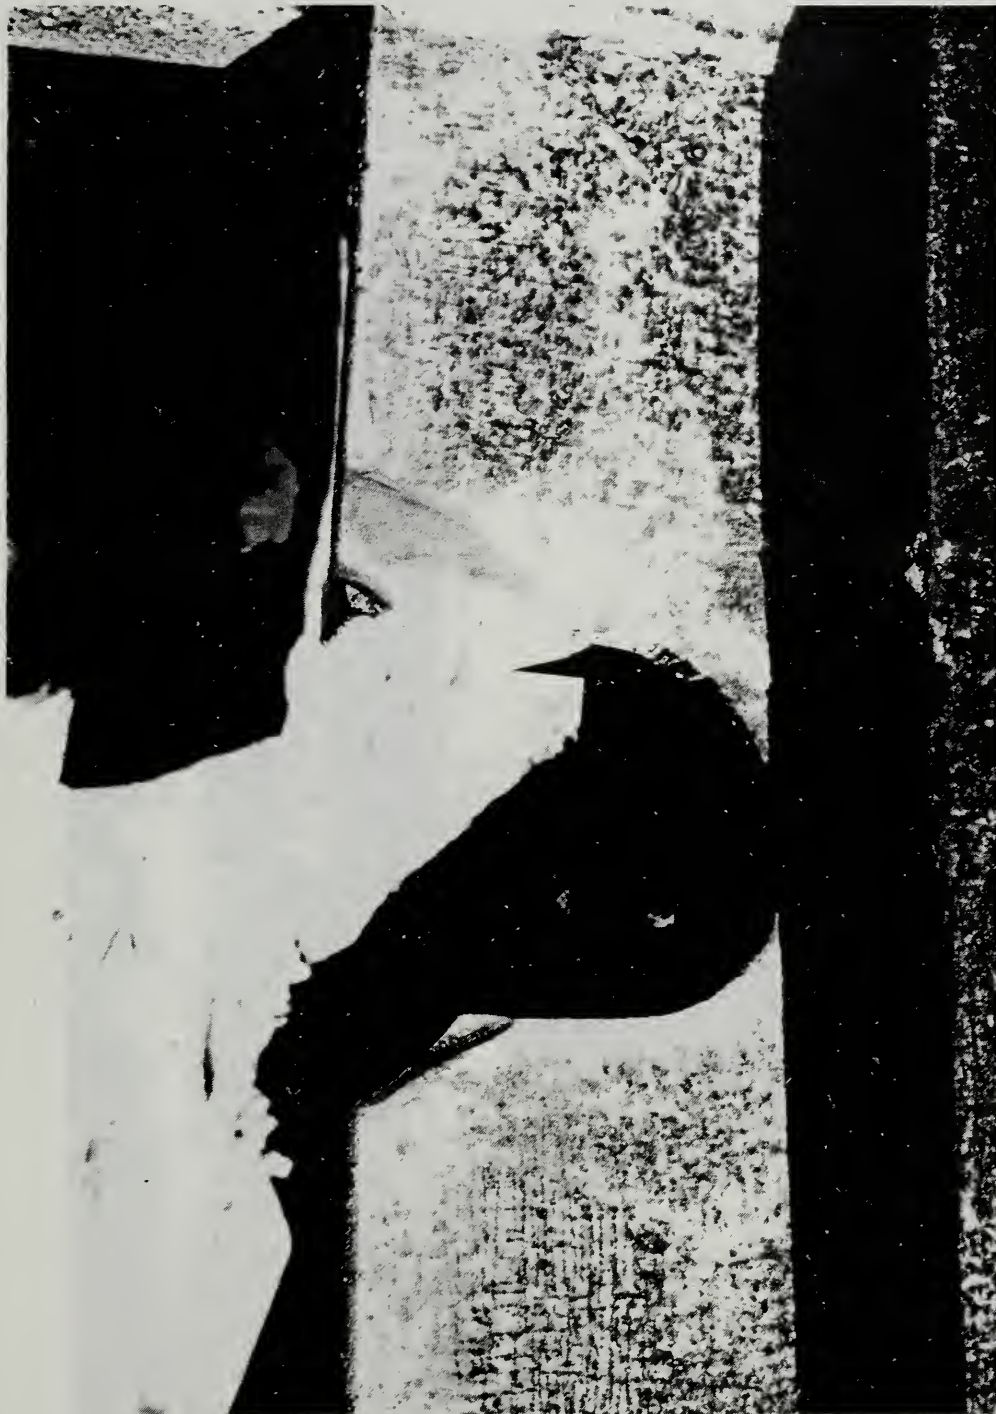
Figure 9.3.4 Indentation in underside of lifting angle,
column E3.8, level 10

As has been noted in the discussion of test results in Section 5.5.5, a jack load of 190 kips (845 kN) acting on the type X51 shearheads of column E3.8 would produce very significant rotations of the lifting angles, possibly leading to kick out of one or both of the lifting nuts. The bottom surfaces of the lifting angles of the shearhead at slab 9, column E3.8, are shown in figure 9.3.3. The marks on these surfaces show that kick out did indeed occur. This sudden release of energy would be expected to raise dust from the surfaces of the concrete slabs and the noise associated with the kick out experienced in the lifting assembly tests described in Section 5.5.5 could readily be described as steel breaking under stress. This is consistent with the eyewitness accounts (#3 and #4 - figure 4.3.1). The surviving witness working at column E4.8 at the time of the collapse (#14 - figure 4.3.1) noted that the first indication of a problem was a loud noise either right above his head (E4.8) or more towards the center of the slab (E3.8). Due to load redistribution, loss of a jack at either E3.8 or E4.8 would lead to failure of the other jack. As floor slabs 9/10/11 moved downward, the shears and moments in the slabs adjusted to the new support conditions. Because the post-tensioning tendons now were located in the compression side of the slabs, the tendons adjacent to columns E3.8 and/or E4.8 became ineffective and flexural cracks developed in the bottom face of the slabs. This explains the sudden appearance of cracks in the slab directly above the workmen who were installing wedges at column E4.8. The underside of shearhead 10, column E3.8, is shown in figure 9.3.4 and that of shearhead 11 is shown in figure 9.3.5. It appears that one of the lifting nuts glanced off of the web and became partially lodged under shearhead 10. As the slabs moved downward due to loss of support at column E3.8, the lifting nut was again kicked out from under a lifting angle. The imprint on the underside of shearhead 11 suggests that this process was repeated for a third time. It was not possible to confirm this sequence of events with lifting nut impact points on the web because the top section of column E3.8 could not be positively identified. The likely progression of the collapse through the upper levels of the west tower is described in the following paragraphs.
